Manhole Inspection Summary

Manhole # S13UU_011MH

Insp Date: **7/2/08 4:54 PM**

Location Address: **N DUKELAND ST**

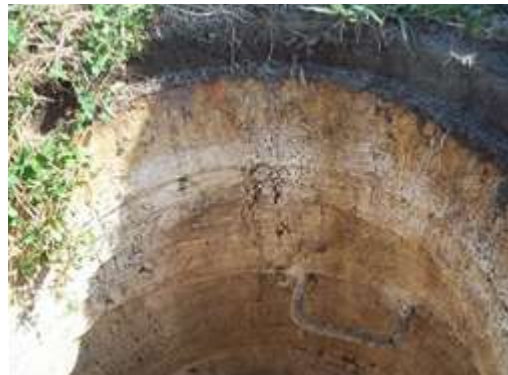
Defect 4

Infiltration: ☐ None ☐ Joint ☐ Cracks ☐ Mortar ☐ Roots ☒ **Wall**

INFILTRATION AT BARREL

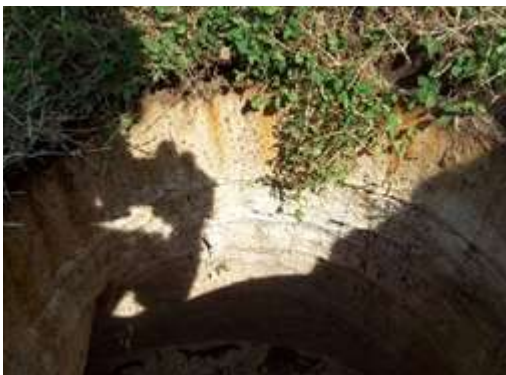
Defect 3

Condition: ☐ Sound ☒ **Cracked** ☐ Root Intrusion ☐ Loose Brick ☐ Deteriorated

CRACKED AT CORBEL

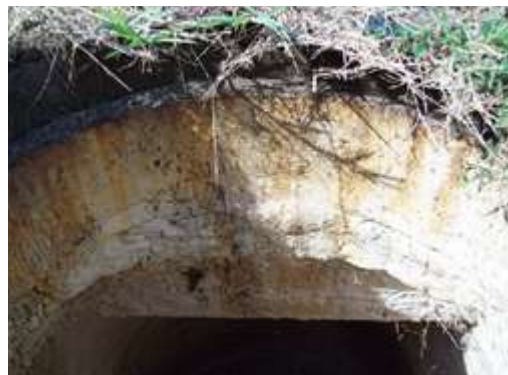
Defect 2

Infiltration: ☐ None ☒ **Joint** ☐ Cracks ☐ Mortar ☐ Roots ☐ Wall

INFILTRATION AT CORBEL

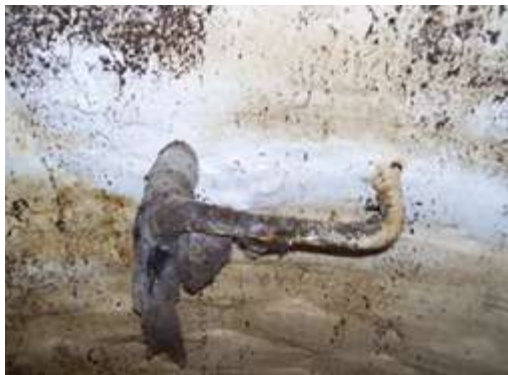
Defect 1

Surcharge ☒ **Evidence Of Surcharge** Depth: **11** (ft.) ☐ Active Surcharge Present

EVIDENCE OF SURCHARGE

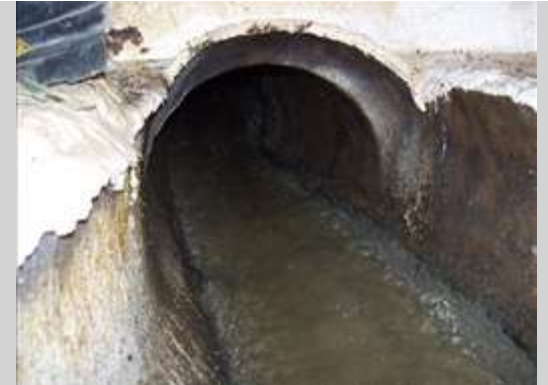
12 O'Clock Outflow

12 in. Circular Gravity Sewer
Pipe Out @ 12 O'Clock

Pipe Height: (in.) Direct
Pipe Material: **PVC** ☐ Pipe Lined
Invert Depth: **17.90** (ft.) Flow Characteristics: **Fast**
Deposits: ☒ None ☐ Mud ☐ Sludge ☐ Debris ☐ Grease
Silt Depth: (in.) Deposits Extent:
Infiltration: **None** Pipe Seal Cond: **Sound**

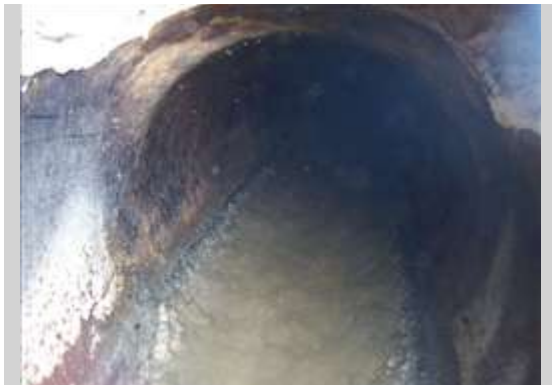
6 O'Clock Inflow

12 in. Circular Gravity Sewer
Pipe In @ 6 O'Clock

Pipe Height: (in.) Direct
Pipe Material: **PVC** ☐ Pipe Lined
Invert Depth: **17.80** (ft.) Flow Characteristics: **Fast**
Deposits: ☒ None ☐ Mud ☐ Sludge ☐ Debris ☐ Grease
Silt Depth: (in.) Deposits Extent:
Infiltration: **None** Pipe Seal Cond: **Sound**
